# Training Manual

## Safety Assessment Program (SAP) Evaluator

**Response and Recovery Division**

**January 2005**

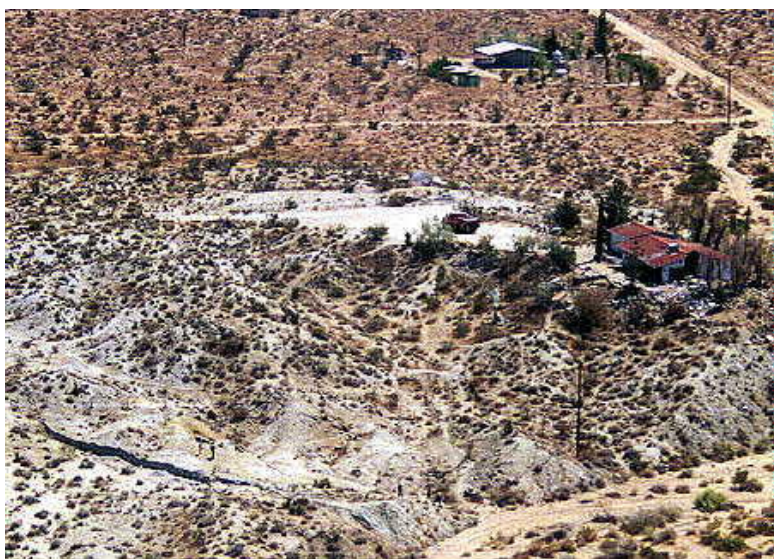
**Figure 2-1 - Near Field Effects - Landers/Big Bear Earthquakes, 1992**

In this particular series of photographs, the subject house was very close to the epicenter of the event. Interestingly enough, structures in the close vicinity of this home suffered only minor damage, where this one was destroyed.

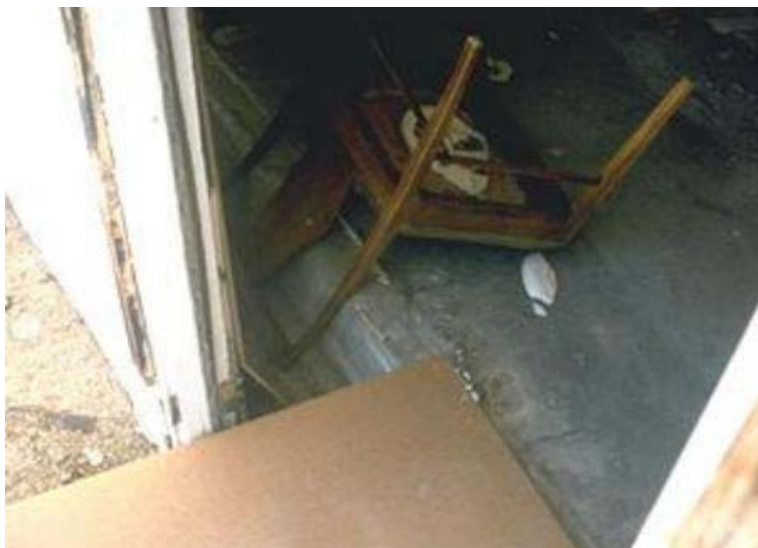
**Figure 2-2 - Near Field Effects - Landers/Big Bear Earthquakes, 1992**

The home had been built on a concrete slab on grade with minimal connections of the sill to the slab. In Figure 2-2 we see that the structure physically moved laterally about 6 inches. In order for this to happen, the connections of the wall sill plate to the slab had to fail. In fact, the vertical component of the motion caused the roof and walls to lift and the connections to the slab begin to pull through the sill plate. The simultaneous lateral ground motion caused the ground and slab to move laterally bending the bolts and causing them to pull the rest of way through the sill plate. This type of severe ground movement results in significant levels of damage to the structure and contents.

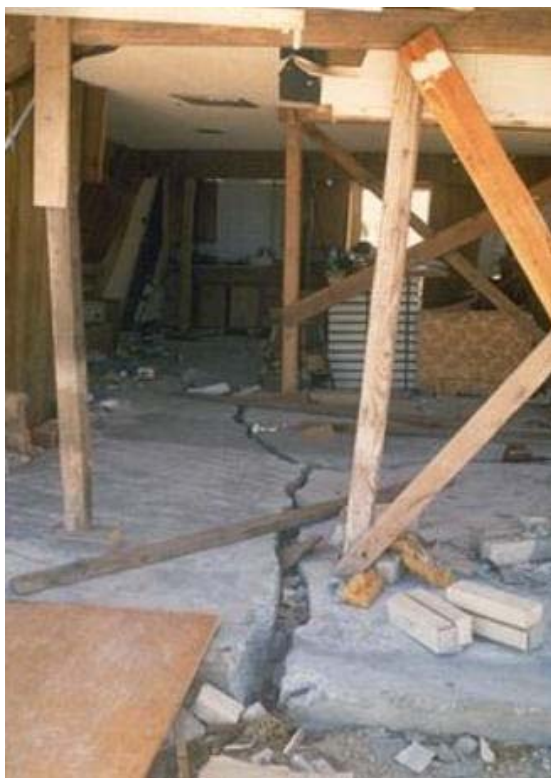
**Figure 2-3 - Near Field Effects Landers/Big Bear Earthquakes, 1992**

On the right side of the fracture in the slab at the edge you can see the bent anchor bolt which still has the nut and washer in place. This would indicate that the sill bolt pulled through the sill plate as the structure was thrown upward. In the previous figure (the opposite side of the house) you see that the structure was also displaced laterally. Every sill bolt was pulled through the sill plate. In this view, the entire wall of the home collapsed and fell away from the structure. The large cracks in the floor slab are an indication of the severe ground movement.

Figure 2-1 through Figure 2-3 show the dramatic effects on structures within the near field. Figure 2-1 shows a home (upper right) that was in the near field during the Landers Earthquake of 1992. In the lower left you can see the trace of surface faulting and its location relative to the house. This trace is visible because of an approximately three-foot up thrust or vertical displacement along the trace. The up thrust took place in a matter of seconds as the fault rupture passed through. This is visual evidence of a vertical component to the ground motion that affects structures. The result of the horizontal and vertical motion on the home in the background is shown in Figures 2-2 and 2-3. This is a graphic example of the near field effects on short, stiff structures.

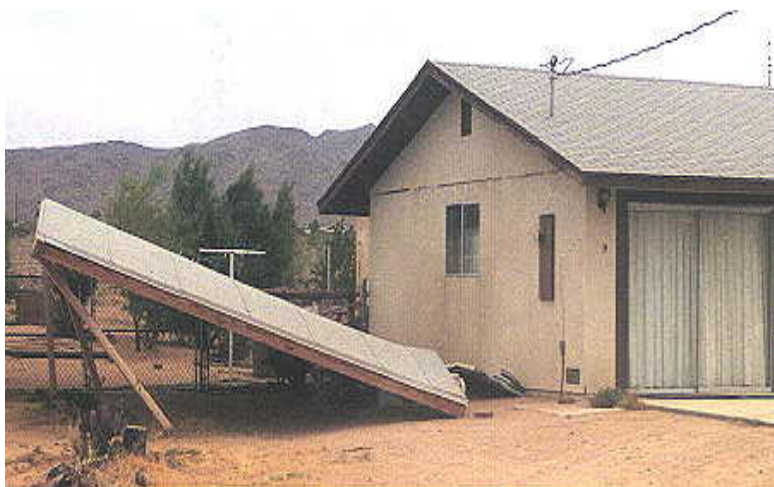
**Figure 2-4 - Home - Landers/Big Bear Earthquakes, 1992**

Figure 2-4 shows a home that has been damaged locally in that the carport has collapsed. There was no damage to the home and no threat to the occupants. The carport represents only a minor hazard in its current condition. The house could be posted **INSPECTED** (or Green) since there is no direct hazard to the occupants. The area around the carport could be posted as an "area unsafe." On the placard, in the Comments Section, a notation that once the carport is taken down the area unsafe condition could be removed would be appropriate. The same notation would also appear on the evaluation form. If, for example,

the carport had not fallen but was still marginally attached to the house, the condition of the structure could change to **LIMITED ENTRY** or **RESTRICTED USE** (yellow).

The restriction on occupancy would be to not occupy rooms on the carport side of the home until such time as the carport was removed or repaired. The damage to the carport is a falling hazard that poses a threat to anyone in the vicinity of the carport. The hazard would be outside the structure and should be posted as "area unsafe."

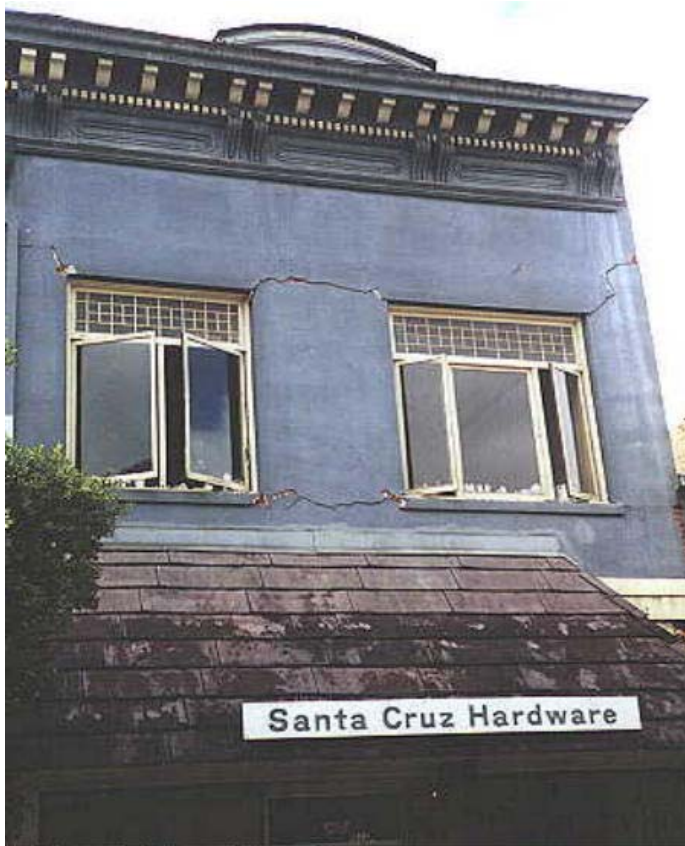
**Figure 2-5 - Commercial Building - Loma Prieta Earthquake, 1989**

Figure 2-5 shows a condition that represents a decrease in the lateral capacity of the wall. However, this condition is not necessarily a significant decrease in that the piers are still able to resist forces without collapsing by rocking on their base. From a safety assessment standpoint, this is a serious condition but not one that would preclude entry to the building for possession retrieval. Consideration should be given to restricting access to this front portion of the building until the wall can be stabilized.

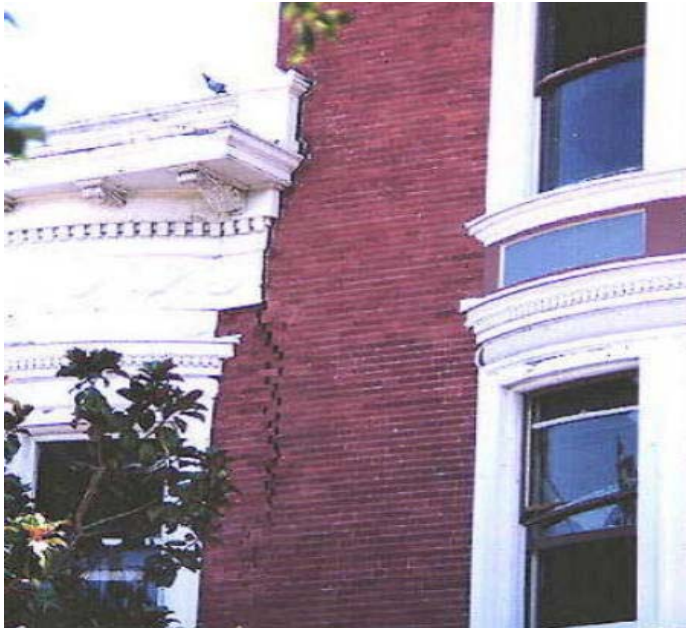
Figure 2-6 - Loma Prieta Earthquake, 1989

Figure 2-6 shows damage as a result of pounding of different height buildings. The damage seen in the brick veneer occurs just at and below the floor line. The broken windows are also an indication of the level of motion experienced by the building. If the evaluation were a rapid evaluation (discussed later in this unit) the most appropriate placard would be **LIMITED ENTRY** or **RESTRICTED USE**. Due to the potential for damage to the support of the floor framing, initial restrictions on occupancy would be severe in that no entry into the area around the damage would be permitted, and access to other parts of the structure would be for possession retrieval only. A detailed evaluation, where access to the interior would be provided, may show little or no damage to the support of the floor framing. In this case the restrictions could be modified to provide free access, or the condition of the building could change to **INSPECTED**.

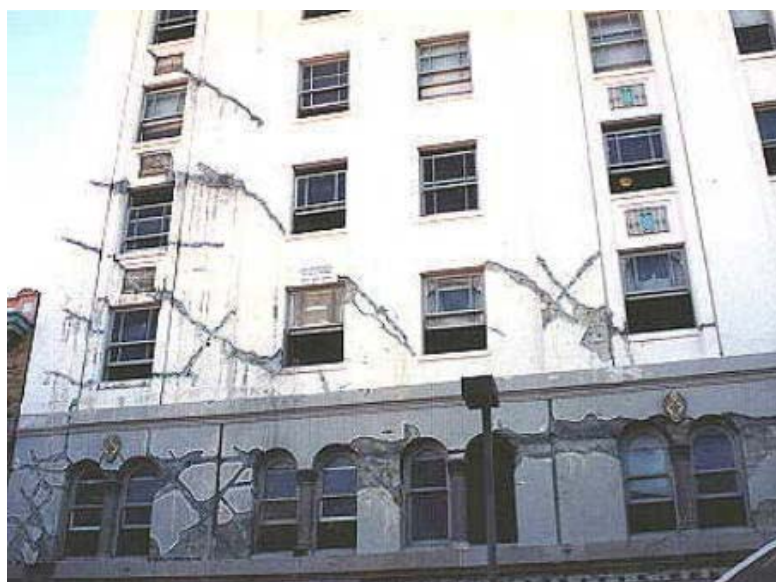
Figure 2-7 - Loma Prieta Earthquake, 1989

The condition shown in Figure 2-7 can be considered as a significant decrease in lateral capacity. This picture was taken as the building was being repaired and emphasizes the cracks in the wall piers. These cracks are a result of diagonal tension in the pier from in-plane lateral forces the wall was subjected to. This type of cracking is commonly referred to as “shear cracking.”

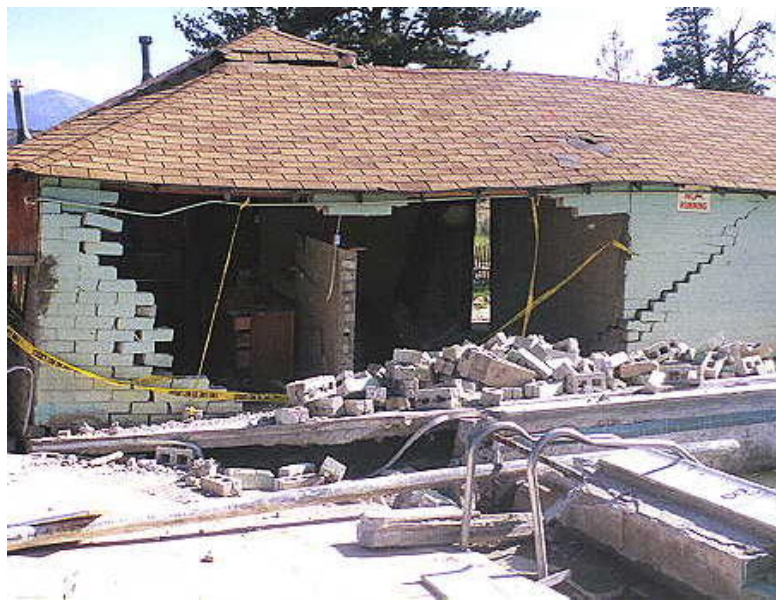
Figure 2-8 - Landers/Big Bear Earthquakes, 1992

Figure 2-8 shows an obviously **UNSAFE** structure from the Landers/Big Bear earthquakes that experienced a partial collapse of the building wall. This picture also shows significant problems in relation to the pool. This structure is located in Big Bear near the epicenter of the Big Bear earthquake. Vertical ground motion could have pushed the pool upward or sufficient amounts of pool water could have been “sloshed” out of the pool and into cracks in the surrounding slab causing the pool to float and the surrounding slabs to subside.

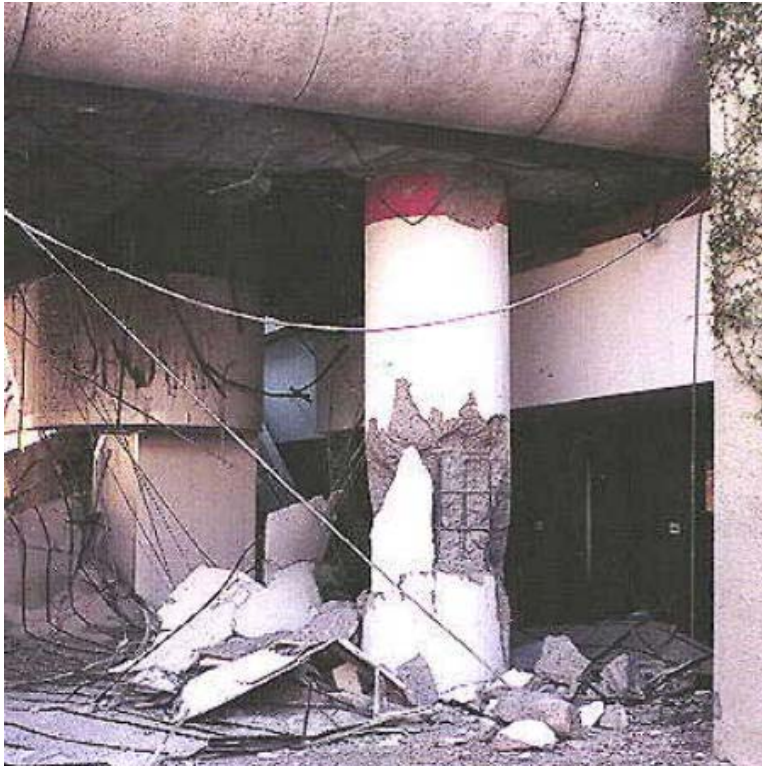
**Figure 2-9 - Department Store - Northridge Earthquake, 1994**

Figure 2-9 shows a large concrete column supporting a bridge between the parking structure and a department store that was damaged by the Northridge earthquake. The plaster soffit has also failed and is lying on the ground blocking easy access to the department store. The damage to the column appears to be spalling of the concrete cover that probably has not significantly reduced the vertical load carrying capacity of the column. Looking at the thickness of the concrete cover, one can conclude that the column size was for appearance not load capacity. Additionally, the plaster soffit is on the ground so there is no falling hazard. The initial view of the damage could lead one to believe that it looks worse than it really is. Repairs are required, but there has not been a significant loss of capacity.

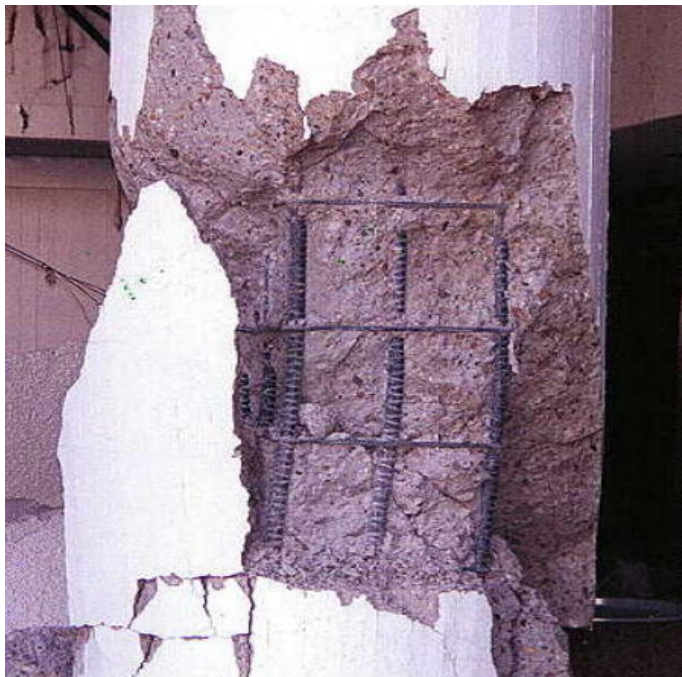
**Figure 2-10 - Department Store - Northridge Earthquake, 1994**

damage until such a time as the column is shored. The large crack in the concrete core indicates that there has been a decrease in the lateral capacity of the element. The existence of both of these conditions is sufficient to post the structure as **UNSAFE**.

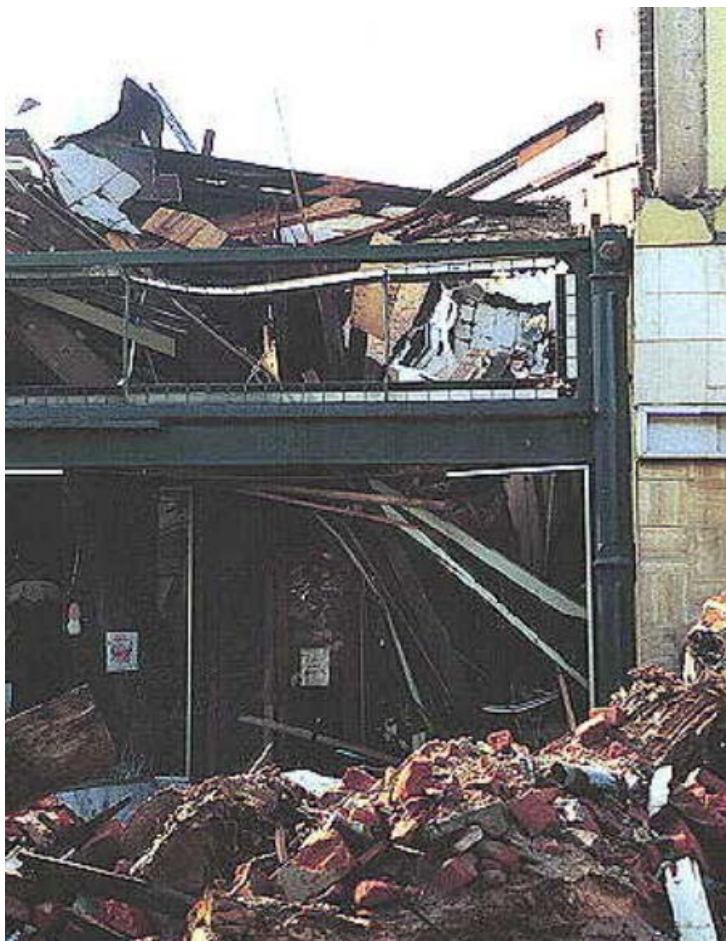
**Figure 2-11 - Loma Prieta Earthquake, 1989**

There are times when a building is obviously unsafe and individuals need to be kept away from the area around the building as well as from the building itself. In this case the **AREA UNSAFE** concept should be used. Figure 2-11 shows an example of this condition. The building is obviously unsafe as a result of a portion of the wall from the adjacent building falling through the roof. There is no question about the condition of the building. However, the fact that a portion of the wall fell indicates that the rest of the wall is more than likely unstable and could come down during an aftershock. Therefore, the desire is keep people well away from both buildings. Using the **AREA UNSAFE** designation in combination with some form of barricade will provide a reasonable level of protection until the hazard can be addressed.

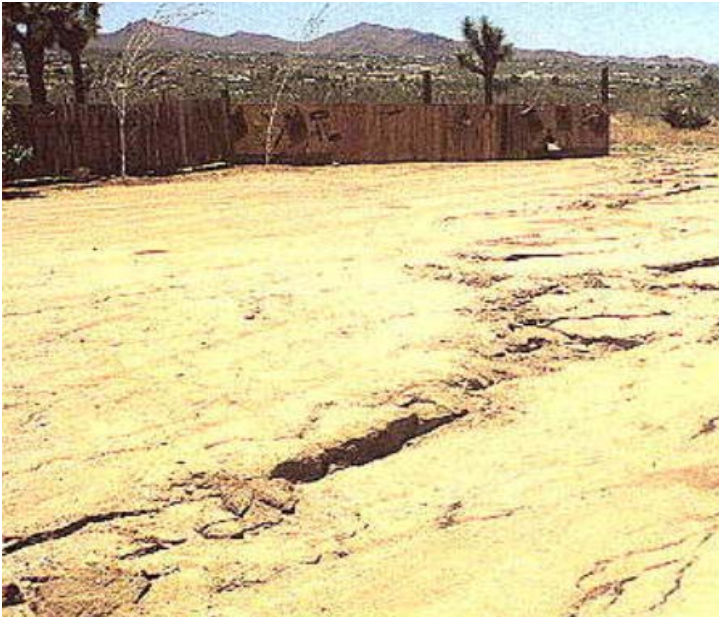
**Figure 2-12 - Landers/Big Bear Earthquakes, 1992**

The Landers/Big Bear earthquakes presented geologists and seismologists tremendous opportunities to study surface faulting conditions. From the standpoint of the Safety Assessment Program, surface faulting can constitute an **UNSAFE** condition if the fault trace is “close” to the building, passes under the foundation, or occurs next to a slope. There are no clear criteria for “close;” this will depend on the judgment of the evaluator. Fault traces passing under a building can lead to differential settlement and damage to foundations that is not readily visible. Traces located next to a slope (either at the top or the toe) can lead to a later failure of the slope resulting in a landslide.

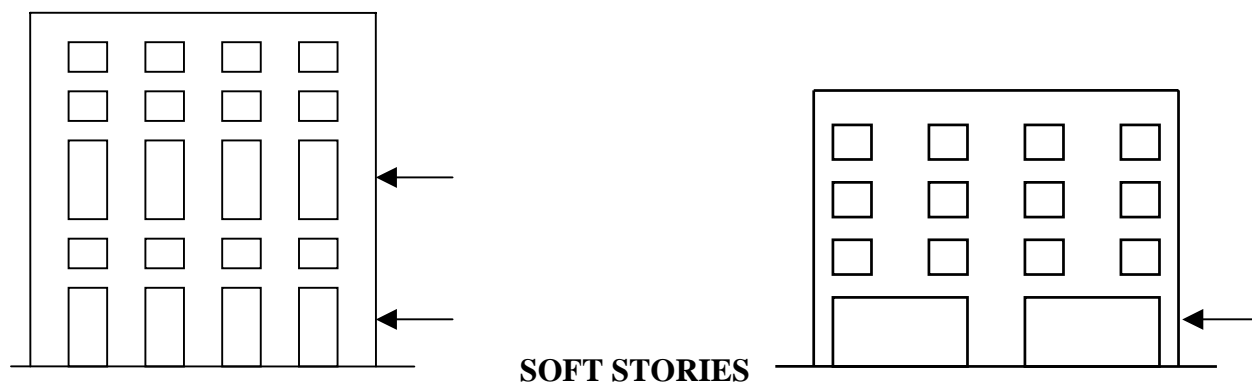
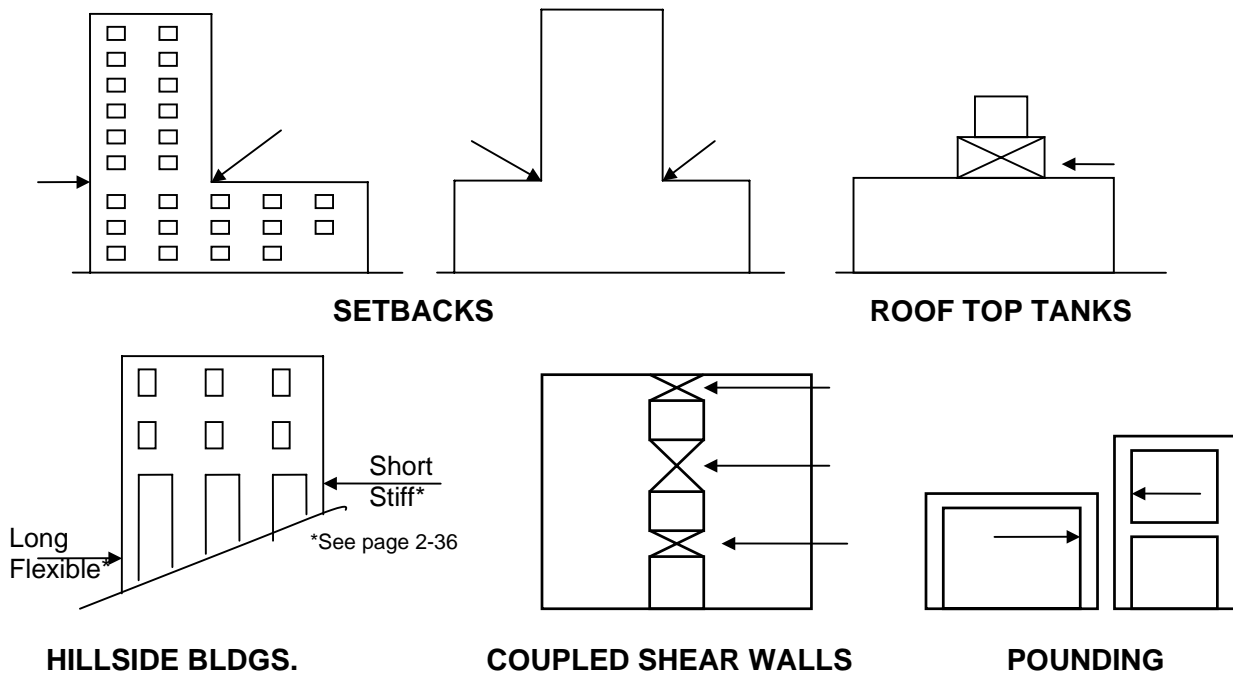
**Figure 2-14 - Vertical Discontinuities**

As you move around the building while performing your investigation, make sure that you pay particular attention to vertical discontinuities and plan irregularities. The arrows indicate where damage is most likely to be found.

For the hillside buildings shown in Figure 2-14, damage will most likely occur on the uphill side where the columns or panels are much stiffer than the down hill side. Because these elements are stiffer they will draw more force than the more flexible side. However, the down hill sides should also be reviewed as they may receive damage that would usually be in the mid-height of the element and caused by excessive deflection.

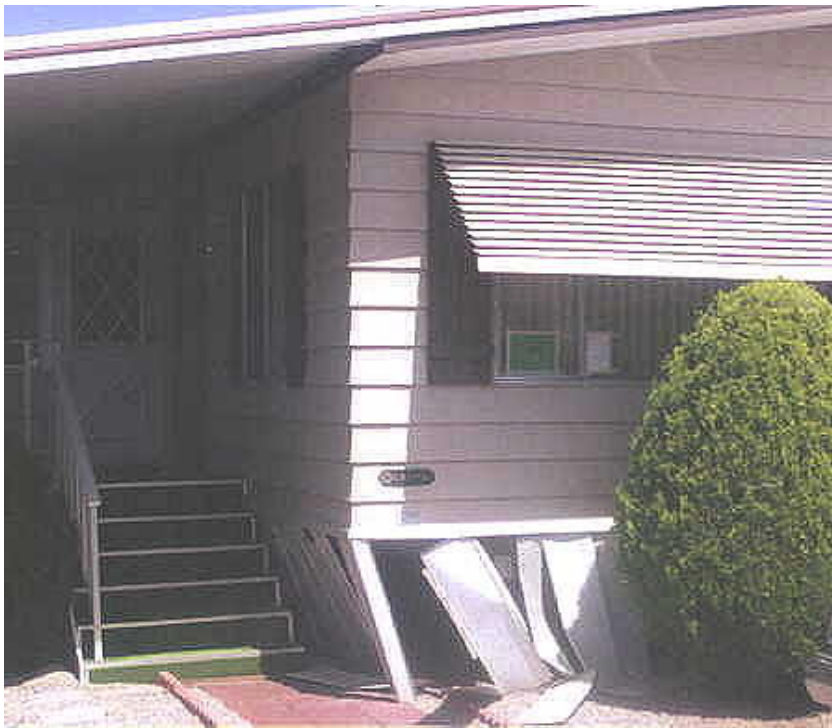
**Figure 3-14 - Mobilehome - Landers/Big Bear, 1992**

If this unit is braced, the fact that it has shifted sideways could lead the evaluator to conclude that the connection of the bracing to the ground may have failed. If it has failed, maybe the more prudent posting would be RESTRICTED USE since aftershocks may cause it to shift even further. If the unit is not braced, then the shifting has caused the jack stands to tip. This unit is highly susceptible to falling even further during an aftershock, and the appropriate placard would be RESTRICTED USE, not INSPECTED.

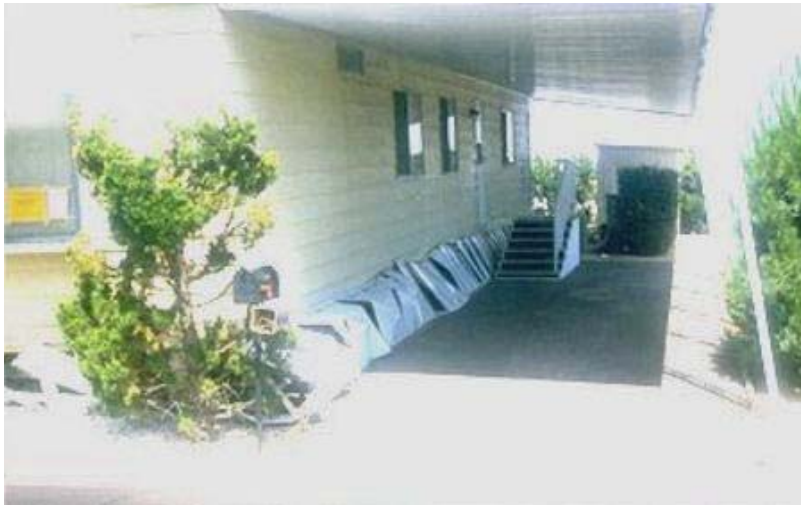
**Figure 3-15 - Mobilehome - Landers/Big Bear, 1992**

In all likelihood it has damaged sewer connections, water lines, gas connections, and possibly electrical connections. An additional hazard exists from the awning in the form of a falling hazard that could pose a threat to life safety. Once utilities are

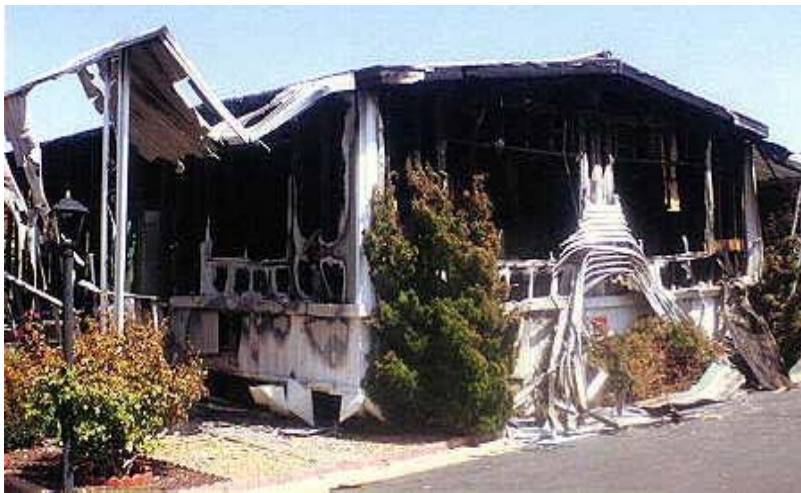
**Figure 3-16 - Mobilehome - Landers/Big Bear, 1992**

It is obvious that this mobilehome has been destroyed and if posting was necessary it would be UNSAFE. This is an example of the combination hazard of moving off the jack stands and the damaged gas line causing a fire. This slide is presented to illustrate the hazards which impact posting once a unit has moved off its jack stands. With the fire out and the gas and electricity turned off, this unit no longer poses a threat to adjacent units. Until the utilities were turned off, there would have been an AREA UNSAFE posting around the unit.

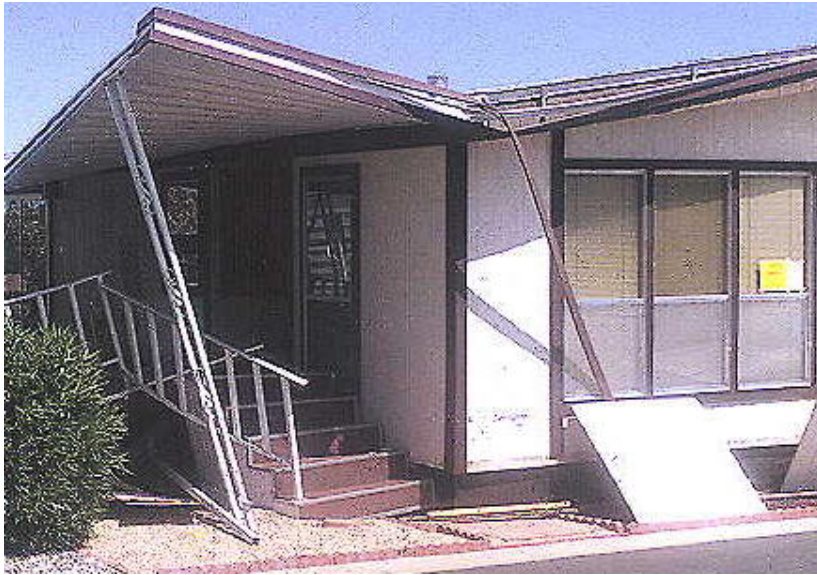
## **UNIT 2 SAFETY ASSESSMENT PROCESS AND PROCEDURES**

In this case the unit is off its jack stands, down and stable—it won't fall any further. However, a falling hazard exists in that the canopy supports are out of plumb as a result of the mobilehome falling off its supports. This could result in the collapse of the awning from an aftershock and, therefore, represents a threat to life safety.

Access to this mobilehome would probably be from the other side provided a landing is not in the way. On this side, the landing is blocking the door opening. If both doors are fully blocked, the posting might be UNSAFE until such time as the landings are moved and the canopy

is removed or braced. At that time the posting can change to RESTRICTED USE. The issue of allowing full-time occupancy follows with the issues on single-family residences. Policies will have to be issued by the jurisdiction.

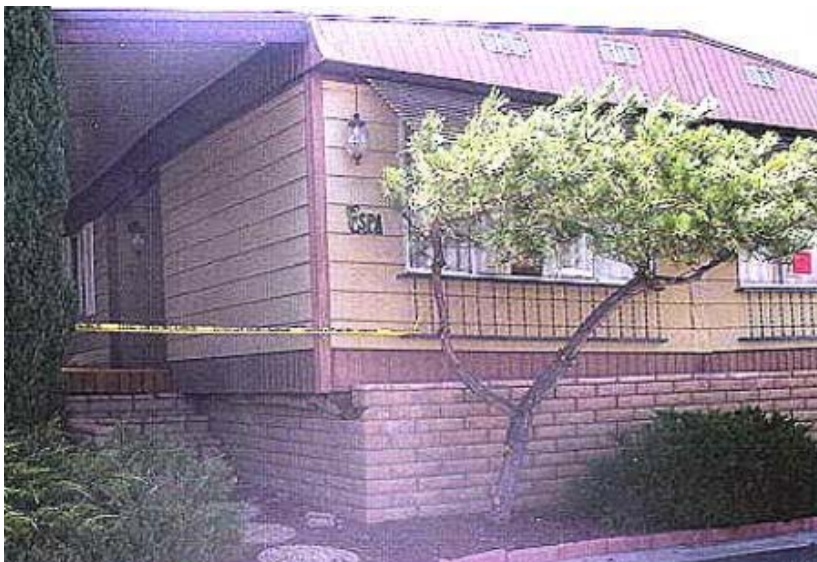
**Figure 3-18 - Mobilehome - Landers/Big Bear, 1992**

In this case, the mobilehome has slid on its brick skirting. Within some parks brick skirting is common. However, this is not a foundation and with displacement, as seen in this photo, the unit can be extremely dangerous because the home's weight may now be resting on the non-structural skirting. Looking in the window, we see that the unit was posted UNSAFE. This is a reasonable posting in this case.

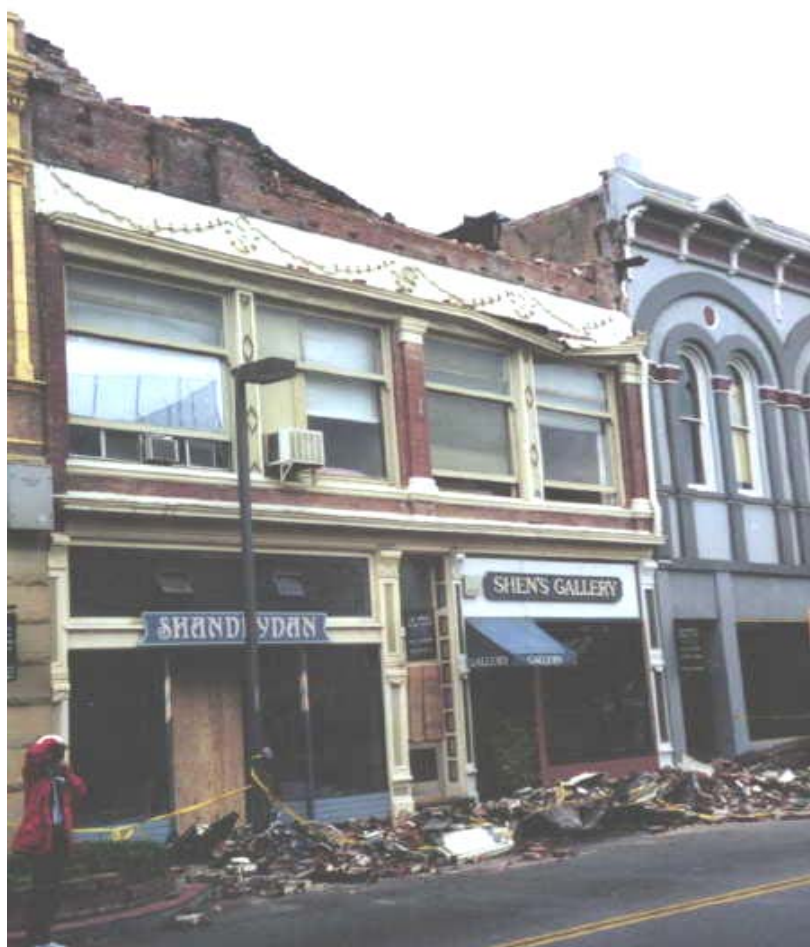
Figure 3-19 - Commercial District - Loma Prieta Earthquake, 1989

The concept of stabilizing buildings is not limited to those that pose an imminent hazard to life safety or the public right of way. In some cases, portions of buildings can be stabilized to reduce a threat that would allow a sidewalk or alley to reopen, or even allow owners or tenants the ability to enter the building for possession retrieval. The methods discussed in this section are not necessarily long-term stabilization measures. Most are measures that will address a specific hazard and allow access to a building or an area.

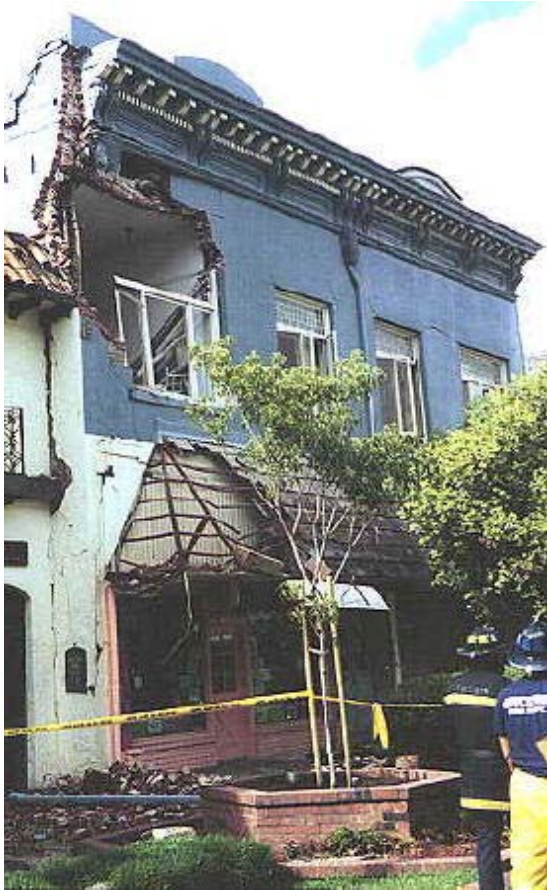
**Figure 3-20 - Commercial District Loma  
Prieta Earthquake, 1989**

As with the last example, this building represents a hazard to the public right of way because of the falling hazard around the window. These loose bricks can fall at any time with or without an aftershock. The front of the building can be easily stabilized through the use of a tieback system. In this case, the connections of the cables would be easier than in the previous example. Using plywood with strong backs, the cables are then passed through the opening and connected to the floor diaphragm. The tie back can be either cable or rods with turnbuckles. This allows the system to be periodically tightened to provide the most protection. Again, once stabilized, the building could be reopened for possession retrieval. As with the previous example, such stabilization measures can provide the owner more time to fully develop a repair program to encompass historic restoration.

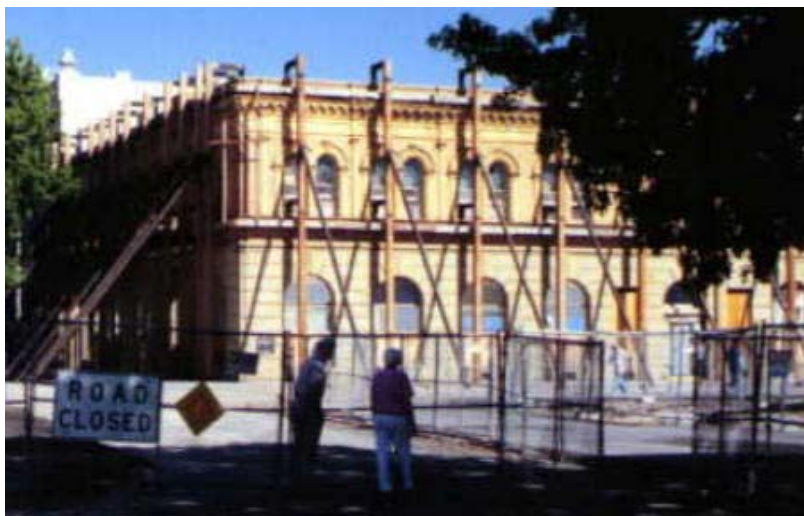
**Figure 3-21 - Santa Cruz, Loma Prieta Earthquake, 1989**

This historic building was badly damaged by the Loma Prieta earthquake. The floor and roof systems separated from the walls and were a distinct collapse hazard. After considerable evaluation and discussion, a system was devised to save the historic character of the building. This is an example of a longer-term, more complicated stabilization procedure that is incorporated within the repair process. Figure 3-22 on the following page provides more detail into the system.

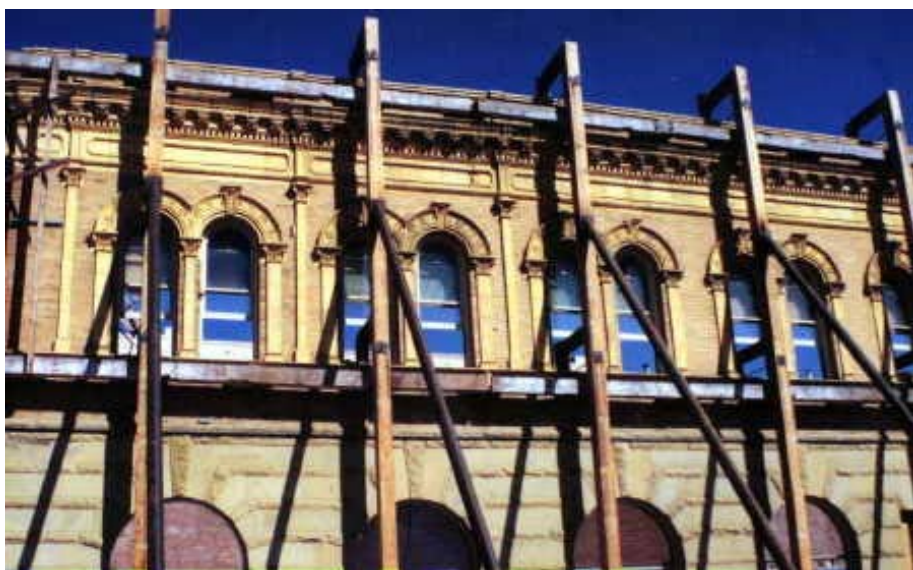
**Figure 3-22 - Santa Cruz, Loma Prieta Earthquake, 1989**

The City deemed this building an imminent hazard. The potential for collapse was great in even a moderate aftershock. Additionally, the building posed a significant threat to the public right-of-way. In this case, the roof and floors were removed and the walls were stabilized with a system of “raker” shores. These are diagonal members connected together with steel beams at the floor and the roofline. They are intended to replace the diaphragms and provide support for the walls for out-of-plane loads.

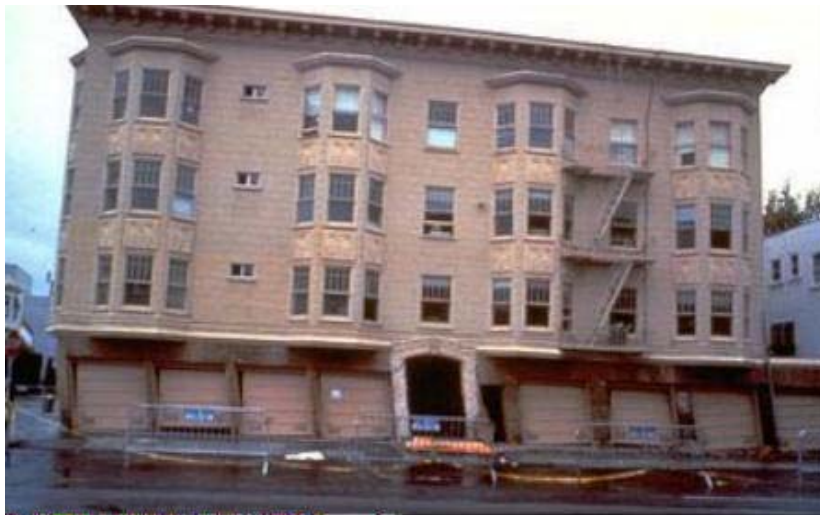
**Figure 3-23 - Marina District, Loma Prieta Earthquake, 1989**

Sometimes a building can look like a total loss, yet a method of stabilization can be devised which can easily be installed, saving the building from demolition. After the Loma Prieta earthquake, there were a number of apartment buildings in the Marina District that had suffered soft story failures.

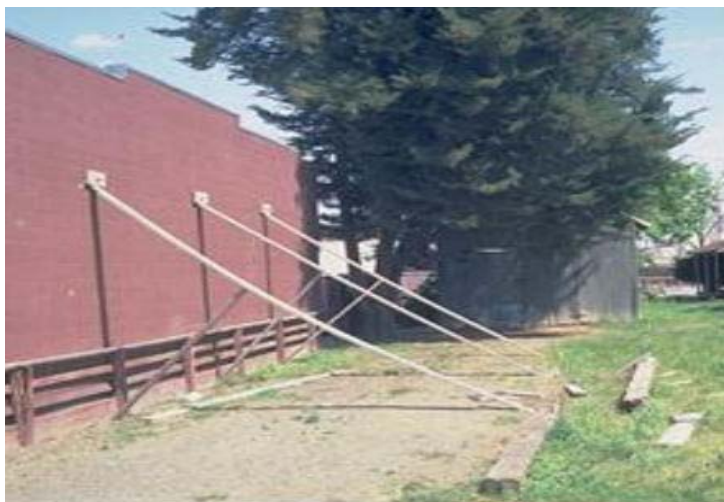
**Figure 3-24 - Tilt-up Building, Coalinga, 1983**

A common hazard with older tilt-up construction is a failure of the ledger in cross-grain bending, leaving the walls without lateral support. The easiest way to brace these walls temporarily is with steel tilt-up wall braces. If the stabilization needs to be installed immediately, and such braces are not readily available, wood braces can be used temporarily, provided they have the capacity to support the walls. In this picture, the braces are too slender to support the wall. They were installed tight, as can be seen by the bow in the braces. Even a moderate aftershock would have the capability to load these braces to a point where they would easily buckle and fail.

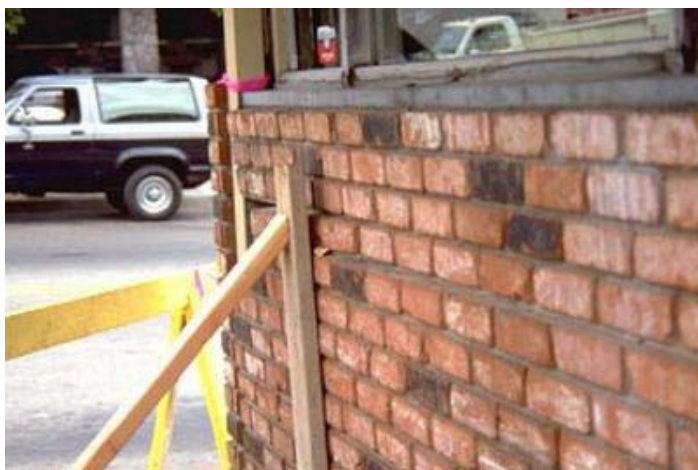
**Figure 3-25 - Sierra Madre Earthquake, 1991**

In this final example, we see a case where stabilizing the veneer on this wall may not have accomplished much. It may have been more cost-effective to simply remove the veneer until it could be re-attached. Since the anchorage failed, the veneer must be removed. In this case it has been shored, but the shoring will have to be removed before repairs to the veneer can be made. Removing the veneer rather than bracing would have accomplished the same thing—removal of the potential hazard.

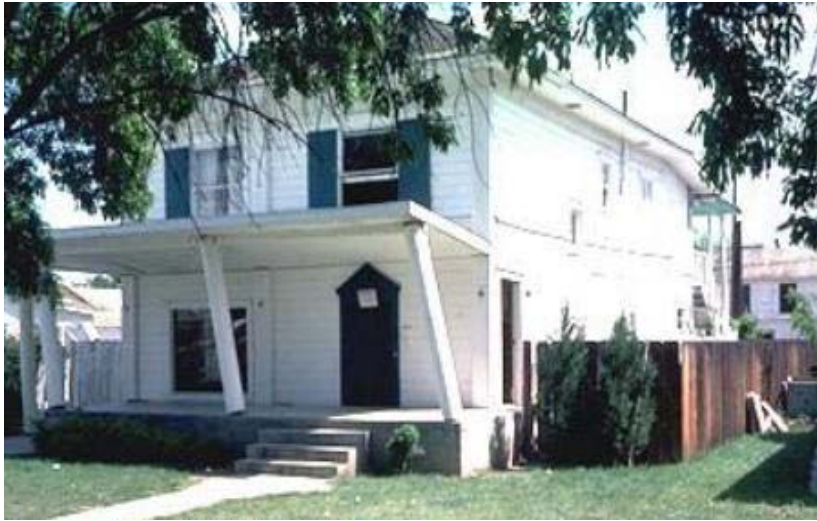
**Figure 3-26 - Home - Coalinga earthquake, 1983**

This picture from Coalinga shows a two-story house that has experienced a cripple wall failure. This failure has resulted in extensive damage to the roof over the porch. The main structure will not collapse further as the walls are in good condition as is the second floor framing. The first floor is reasonably level and the door opens smoothly. Therefore, the structure is stable with the porch roof representing a falling hazard. By using the rear entrance, the home could be considered fully accessible. We know that all utility connections were damaged except electrical connections. Damaged utilities have been shut off.

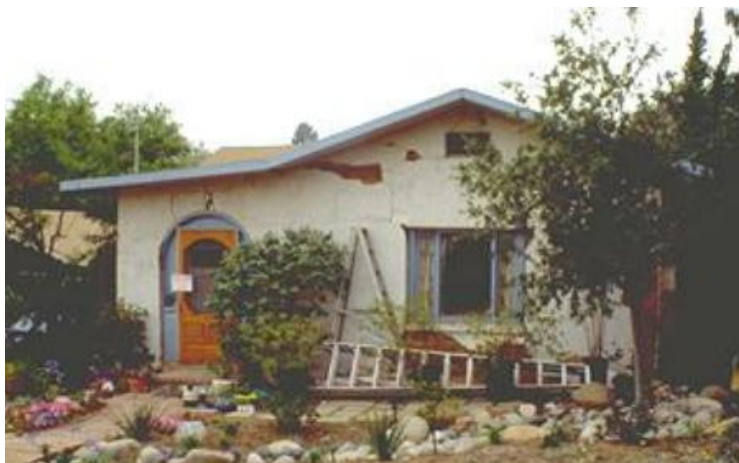
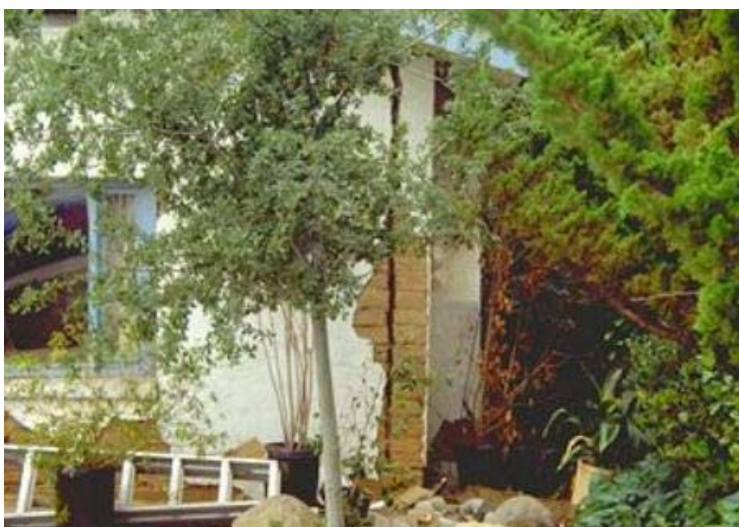
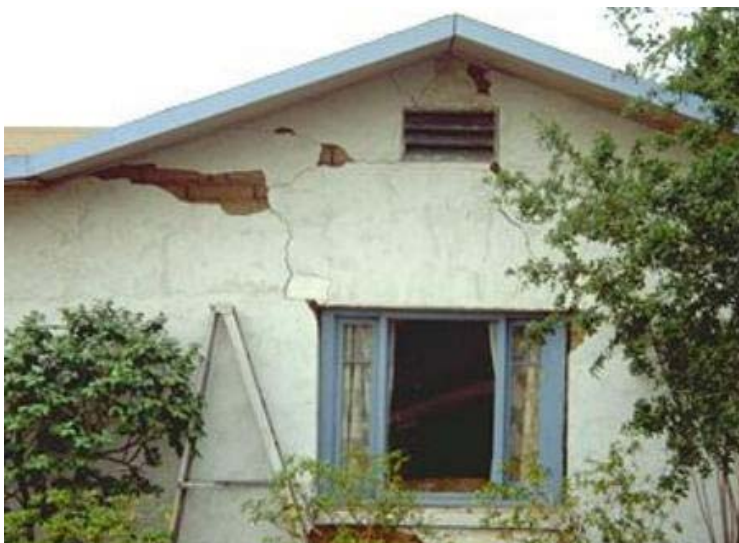
**Figure 3-27 - House - Sierra Madre earthquake, 1991**

This is an adobe home that was damaged by the Sierra Madre earthquake. Damage is extensive at the top of a pier and includes the connecting spandrel. This spandrel connects the damaged pier to the corner pier of the building. Both piers and the spandrel are a part of the lateral force resisting system. Additional damage can be seen at the top corners of the window opening. For the purpose of this review and example, assume that there is no other damage to the building.

This house is also a good example of another type of condition that merits discussion. Looking at this structure one can see that it is constructed of adobe. The initial thoughts are to the safety of the structure prior to the earthquake. Certainly, the structure was vulnerable to earthquake damage because of the nature of the construction. The safety of the structure prior to the event is subject to opinion. Some would certainly say that it was unsafe because it was adobe. However, the earthquake did not cause it to collapse. There are as many opinions regarding the overall safety of adobe structures as there are individuals evaluating these structures. The point of this discussion is that the relative safety of the structure prior to the event is not a consideration in the safety evaluation after the event. This is not intended to identify all the kinds of structures which are vulnerable to earthquake damage and consequently of questionable safety. This evaluation is intended to look at the specific damage to the structure and evaluate the safety for continued occupancy based on the specific damage only.

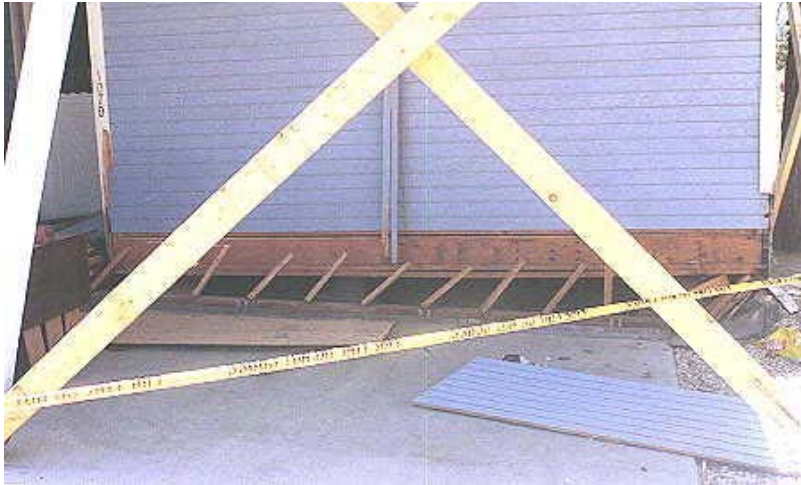
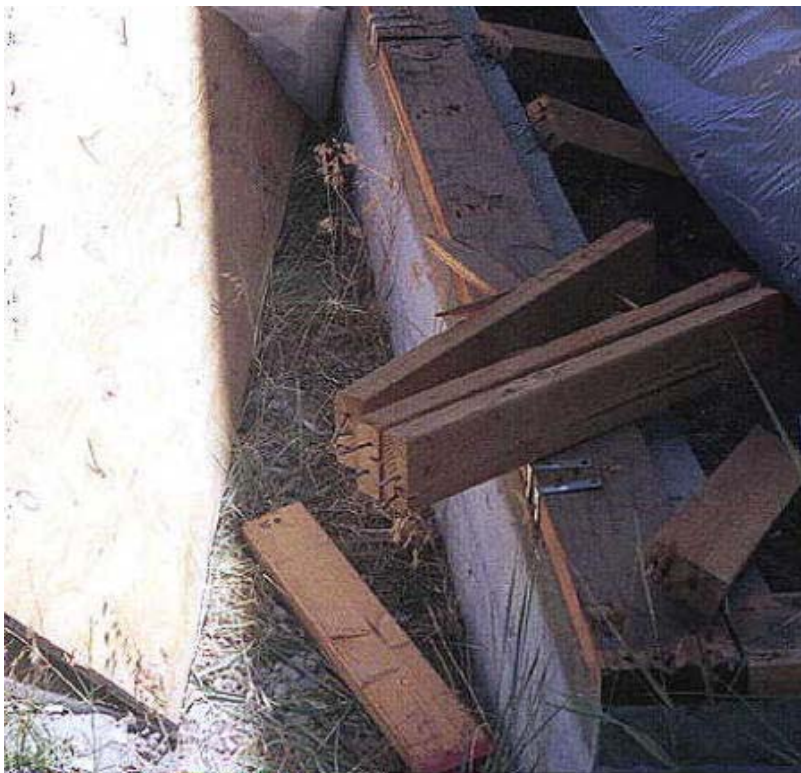
**Figure 3-28 - Home - Landers/Big Bear Earthquakes, 1992**

The Landers/Big Bear earthquakes damaged this home. The home is a two-story structure with a portion of the second story supported by wood posts. This example shows that cripple wall failures are not limited to older construction. The failure of the cripple studs caused the structure to shift to the right, moving off the foundation. The portion of the structure that was two-stories, and supported on wood posts, has been impacted by the cripple wall failure. As the cripple walls of the main portion of the structure failed, and the structure moved off the foundation, the second story portion was pushed out of level since the wood posts were a fixed length.

In this slide, we see why the cripple wall failed. The T111 siding used to resist lateral forces was not nailed to the sill plate. Since this connection was omitted, there was not a complete lateral force resisting system and the structure was free to move laterally. Secondly, we see that the metal straps used as sill anchorage were improperly installed. These straps are intended to come up both sides of the sill plate and nail along the top. In the manner that these straps have been installed, the sill plate is free to tip.

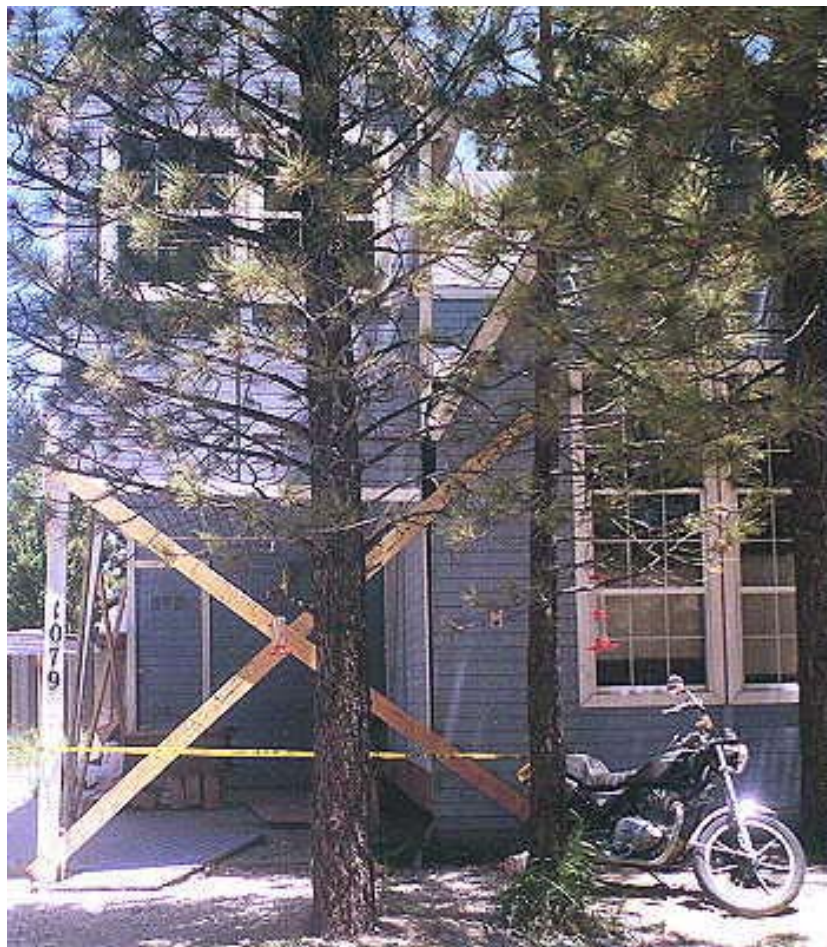
**Figure 3-29 - Home - Landers/Big Bear Earthquakes, 1992**

Figure 3-29 shows a portion of the second floor that extends over an open area. Looking at the soffit line of the room, we can see that it is not level. The portion of the second floor supported by the posts has remained at the pre-event location, while the opposite side, the exterior wall of the lower portion, has dropped because of the cripple wall failure. This creates conditions that preclude occupancy of this second floor portion. In fact, there was little damage above the first floor line. However, with the bracing in place, the structure is accessible. The bracing for this structure was apparently installed randomly by a contractor, or possibly by the homeowners. While stabilizing the second floor for gravity loads, this bracing does little for lateral forces since, at the posts, it is not connected to the ground. This requires that all the lateral force be resisted by the connection of the post to the slab. At the other end the bracing is connected to sheathing that is not connected to the foundation.
